# Ringing Phenomenon during Recovery of Power Diodes

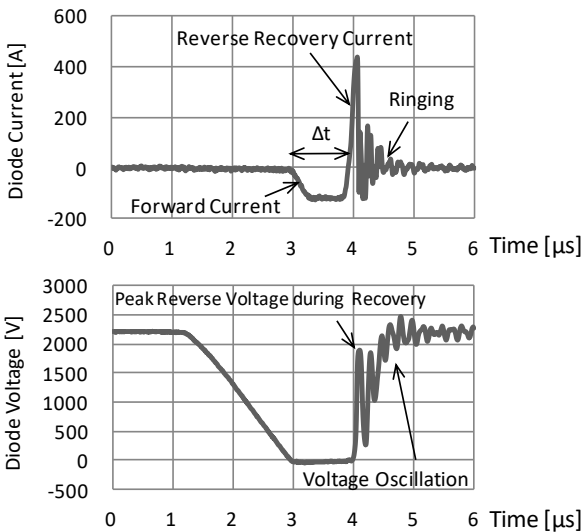
Ringing is caused by the interaction between intrinsic behaviour of the diode chip and the response characteristics of the external circuit. Fig. 1 shows an example of experimental waveforms to highlight the ringing phenomenon. In Fig. 1, the operation current and voltage waveforms of the diode during the recovery period where forward current flows for  $\Delta t = 1$  are shown. Fig. 2 shows correlation between the peak value of reverse voltage,  $V_{RM}$ , and the time period of forward current,  $\Delta t$ . The results show the shorter the flowing period the larger the peak value of reverse voltage.

Fig.1 Experimental waveforms for recovery

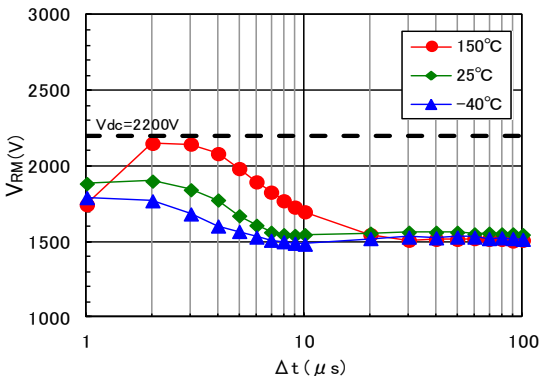
Fig.2 Peak value of reverse voltage

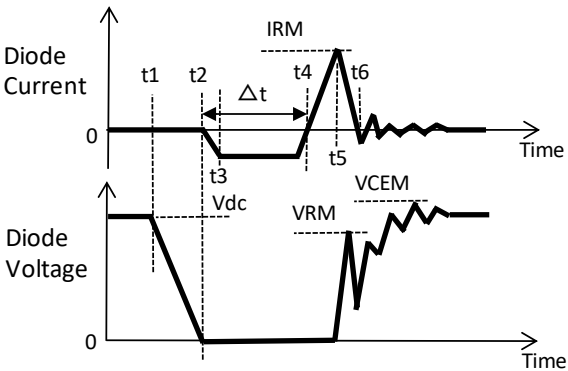
The reason why there is correlation between  $V_{RM}$  and  $\Delta t$  can be explained using Fig. 3 and Fig. 4. During the period from  $t_2$  to  $t_3$  in Fig.3, holes are injected from the p region to n region as shown in Fig. 4(a), and the diode begins conduct. During the period from  $t_4$  to  $t_5$ , diode current continues flowing in the reverse direction until holes stored in n region become extinct by returning to the p region or by recombining with electrons. Further reduction of holes forms a depleted layer in the p-n junction area as shown in Fig. 4(b), and reverse voltage appears at the terminals of diode. During the period from  $t_5$  to  $t_6$ , as holes remaining behind are swept out, current continues flowing and the depleted layer expands while reverse voltage increases. The peak value of the reverse voltage is determined by the product

Fig.3 Recovery phenomenon of diode

of  $di/dt$  as the reverse current returns to zero and the inductance ( $L$ ) of the external circuit. It is important to keep the inductance ( $L$ ) small by laminating electric wiring. If forward current is small or  $\Delta t$  is short, the holes stored in the n region will be low. In that case the reverse current after  $t_4$  will become small allowing the depleted layer to expand rapidly. The subsequent  $di/dt$  in the period from  $t_5$  to  $t_6$  becomes large and a sudden voltage peak may occur.

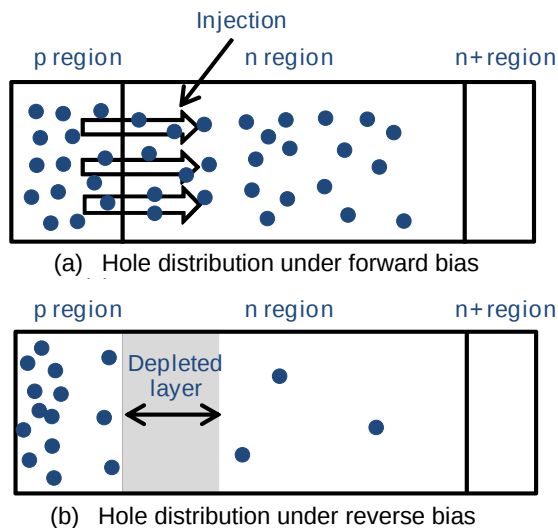
Fig.4 Distribution of holes

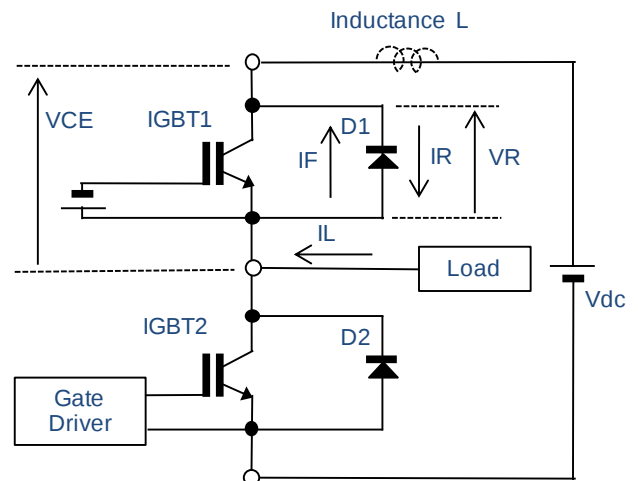
Care should be taken during the evaluation and design cycles to observe if ringing occurs at the application level. An example of a one-phase leg of an inverter employing IGBTs is shown in Fig. 5. Supposing that forward-current  $I_F$  flows through upper-arm free-wheel diode and the lower-arm IGBT turns on, the free wheel diode begins reverse recovery and reverse current  $I_R$  will flow. Where the current  $I_F$  flows for a very short time, the diode recovery may be instantaneous. This short time recovery period may lead to the ringing phenomenon on the free wheel diode. If the load current is very small, close to zero Amperes (0A), the phenomenon has a tendency to occur.

Fig.5 One phase circuit of inverter

During this ringing, the voltage between the collector and emitter of upper-side IGBT may not be stable causing the gate voltage to vary, potentially leading to gate drive circuit malfunctions depending on the severity of conditions. As a pre-caution the behaviour of the diode should be checked thoroughly during validation and a suitable gate resistor should be selected to prevent ringing. Ringing may also occur in any snubber diode. If used it is necessary to carefully choose a snubber diode which generates less ringing.
